## **Vecc-Inspects**

# PROPERTY INSPECTION REPORT FORM

| Home Buyer<br><i>Name of Client</i> | 08/28/2023<br><i>Date of Inspection</i> |
| 123 Inspection Lane, DFW, TX 77777<br><i>Address of Inspected Property</i> | |

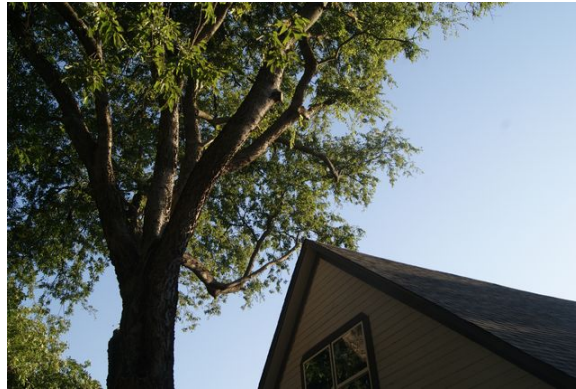
Large trees near the house have limbs that overhang the home. Falling limbs due to conditions such as wood decay, high winds or heavy snow loads may cause injury, death or damage. Significant weakening of large limbs by conditions such as core decay may not be visible by persons without special training. The Inspector recommends having these trees evaluated by a qualified arborist and that limbs that overhang the roof be cut back. Evaluating trees lies beyond the scope of the general Home Inspection.

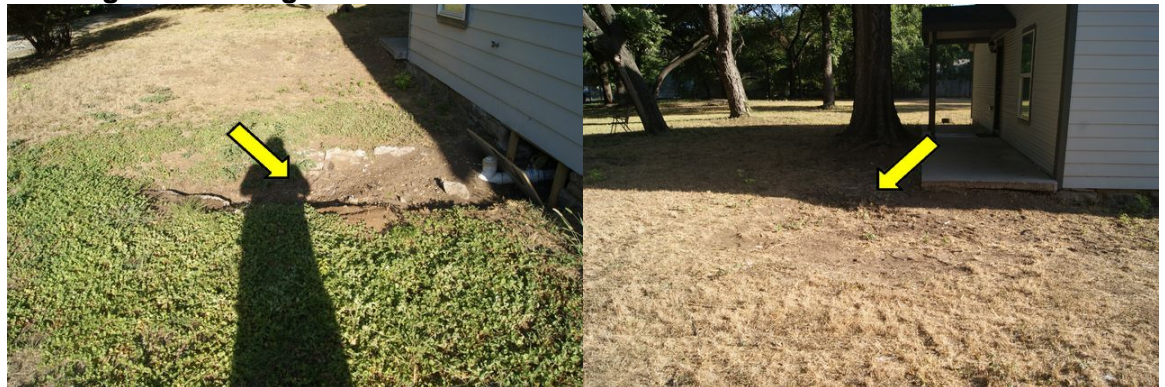
The home had areas of neutral or negative drainage that will route runoff from precipitation toward the foundation. The ground should slope away from the home to help reduce the risk of foundation damage.

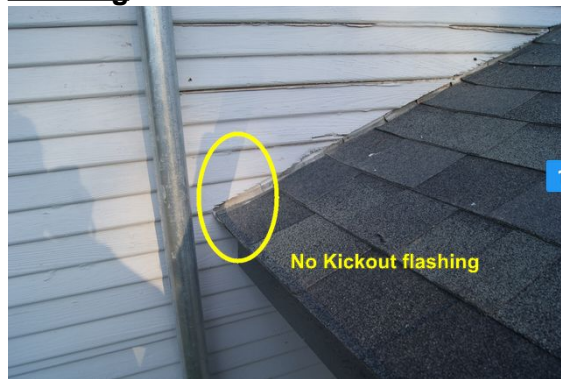
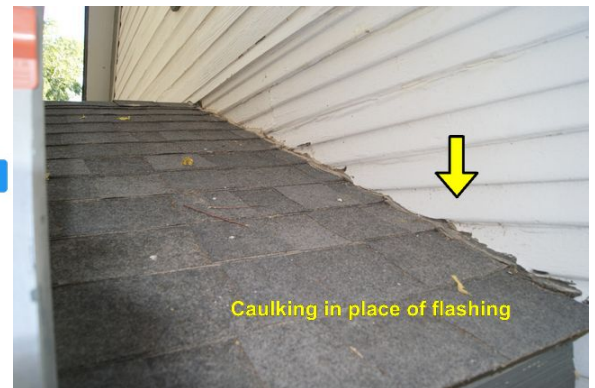
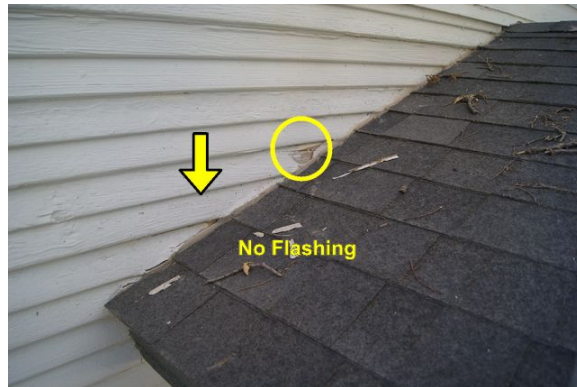
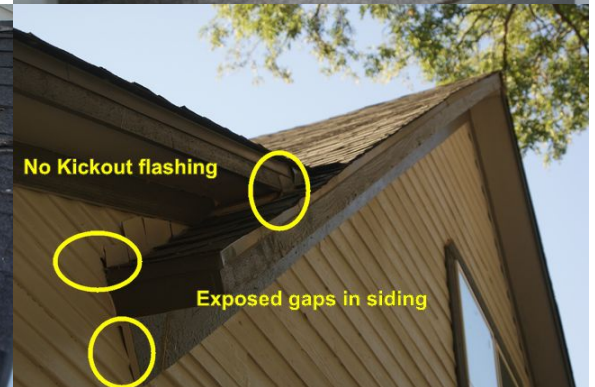
**Flashing**

The home had no kick-out flashing installed where walls extended past roof edges. Kick-out flashing is designed and installed to divert water from behind the exterior wall covering at areas of the home where a sidewall extends out past a connecting roof eave. This condition may allow moisture intrusion of the exterior wall covering. Moisture intrusion of the wall structure can damage home materials and encourage the growth of mold. Long term moisture intrusion can cause structural damage from wood decay. The Inspector recommends that before the expiration of your Inspection Objection Deadline, you consult with a qualified roofing contractor to discuss options and costs for kickout flashing installation.

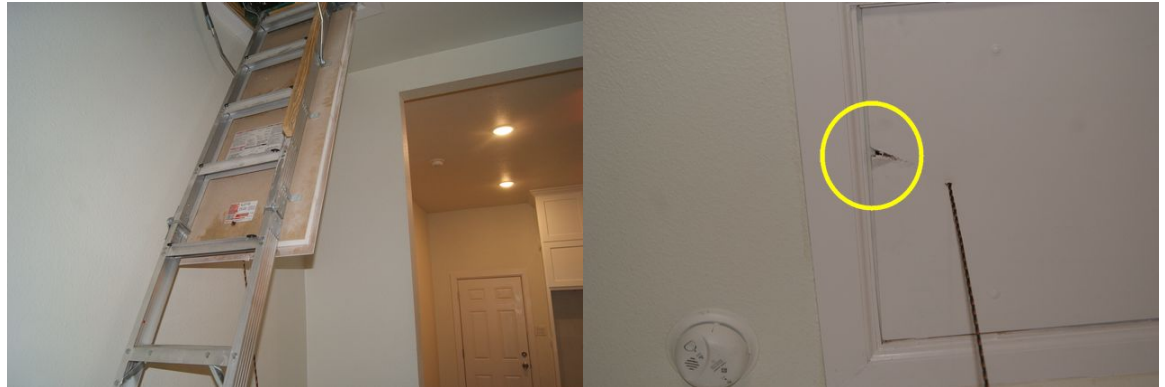
**Attic Access**

Attic door is damaged, recommend repairs be made by qualified contractor.

Recommend weather stripping around edge of attic door to help with energy efficiency.

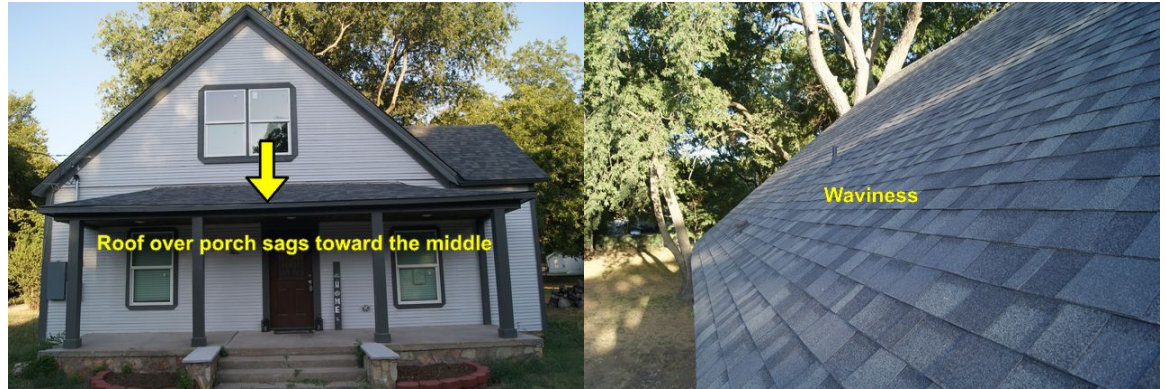
The roof appeared to have a waviness in multiple locations.

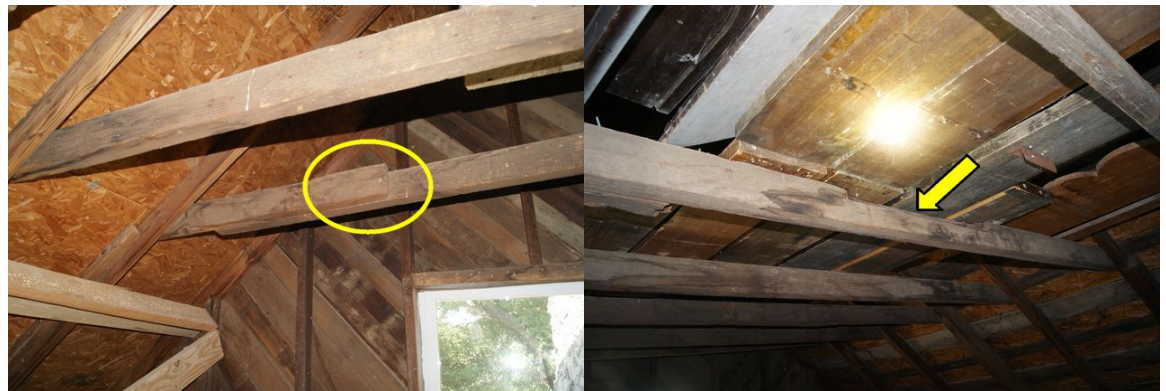
The roof framing had damaged or missing collar ties. Collar ties are specified by engineers or architects for structural reasons. The Inspector recommends that before the expiration of your Inspection Objection Deadline you consult with a qualified contractor to gain an idea of options and costs for replacement of damaged collar ties.

- ◆ The roof framing had damaged or missing collar ties. Collar ties are specified by engineers or architects for structural reasons. The Inspector recommends that before the expiration of your Inspection Objection Deadline you consult with a qualified contractor to gain an idea of options and costs for replacement of damaged collar ties.
- ◆ Rafters were supported by purlins. Purlins are a system of bracing designed to provide added support to rafters to prevent sagging. They consist of horizontal crossmembers fastened to the underside of rafters and supported by braces that bear on the tops of walls. This purlin system does not appear to be installed correctly, Inspector recommends further evaluation and correction by qualified structural engineer.

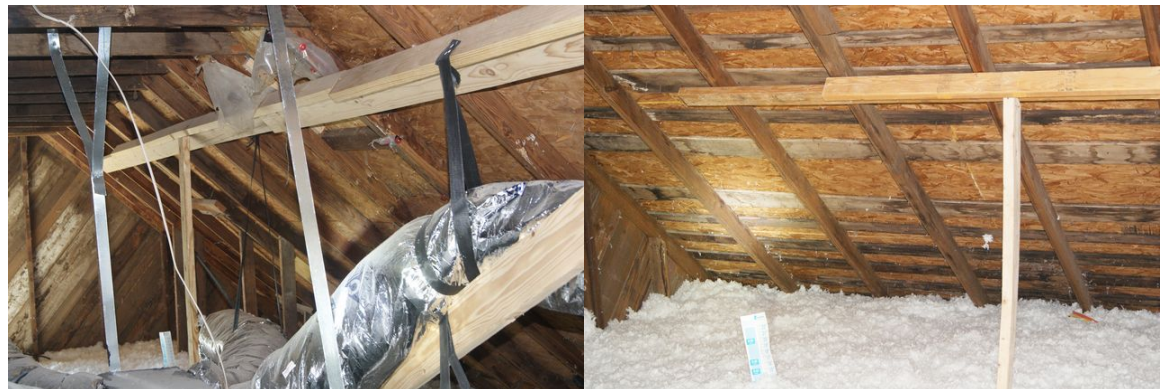
Rafters were supported by purlins. Purlins are a system of bracing designed to provide added support to rafters to prevent sagging. They consist of horizontal crossmembers fastened to the underside of rafters and supported by braces that bear on the tops of walls. This purlin system does not appear to be installed correctly, Inspector recommends further evaluation and correction by qualified structural engineer.

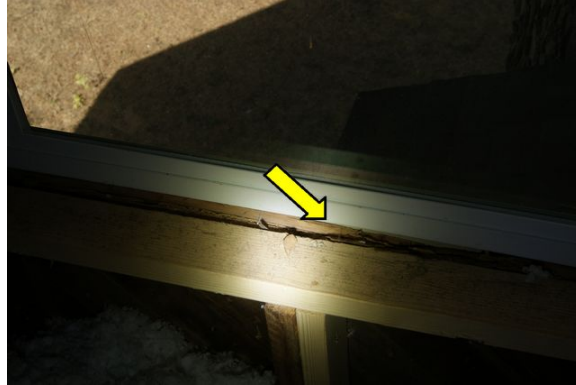
Framing around window in the attic shows signs deterioration.

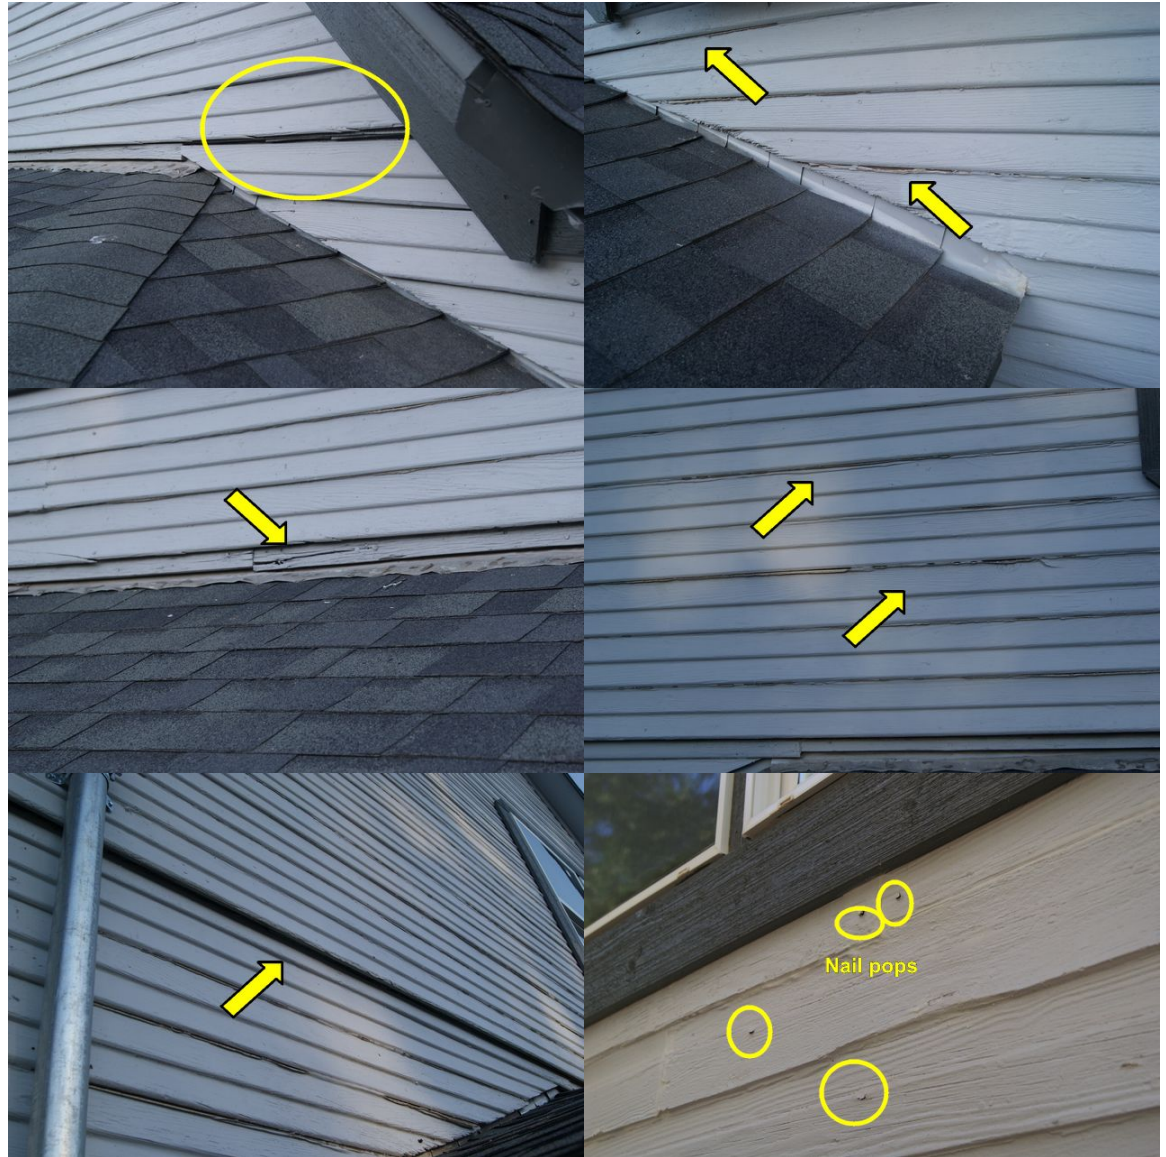
The wood siding covering the front and rear exterior walls of the home appeared to be at or near the end of its useful life. Before the expiration of your inspection objection deadline, you should consult with a qualified contractor to discuss options and costs for application of a new finish coating.

The wood siding had areas in which nails were protruding from the surface. This condition can be caused by long-term expansion and contraction of the wood siding in response to changes in moisture content. The Inspector recommends re-fastening as needed by a qualified contractor.

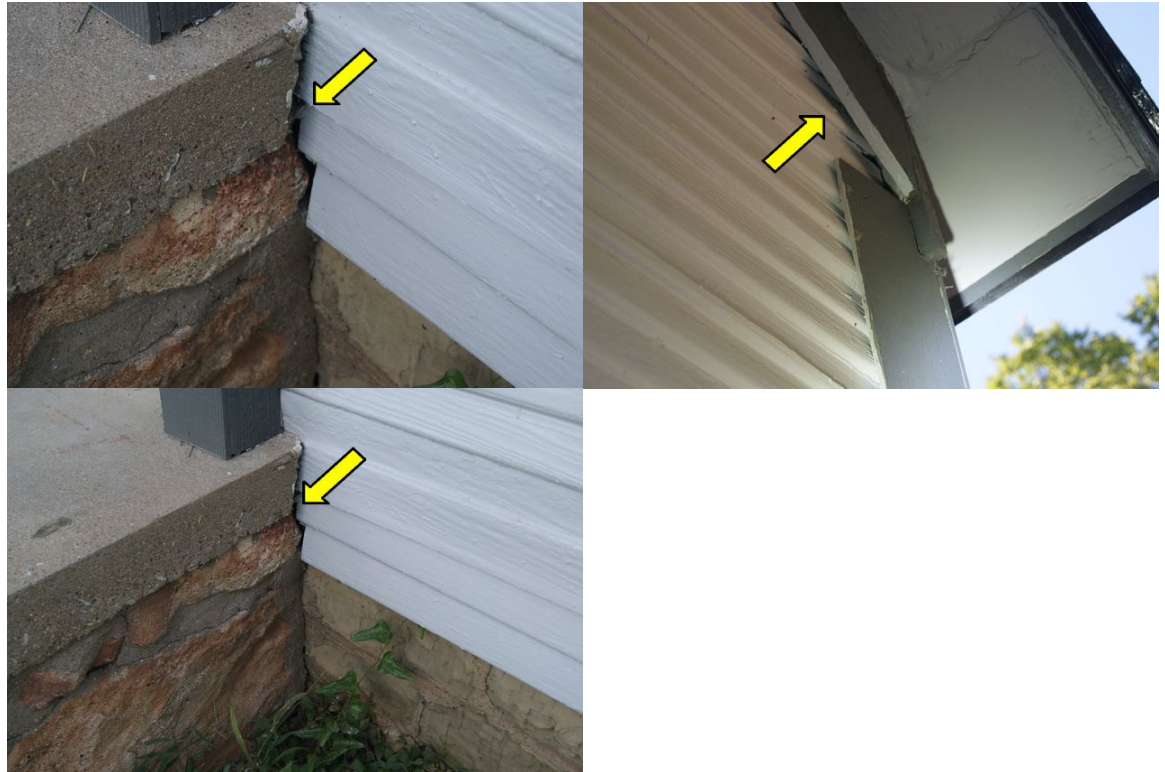
The home had visible gaps in areas of the wood siding covering exterior walls. The Inspector recommends application of an appropriate sealant at these areas to help prevent damage from moisture intrusion to the home materials, the exterior wall structure and to prevent development of microbial growth such as mold. All work should be performed by a qualified contractor.

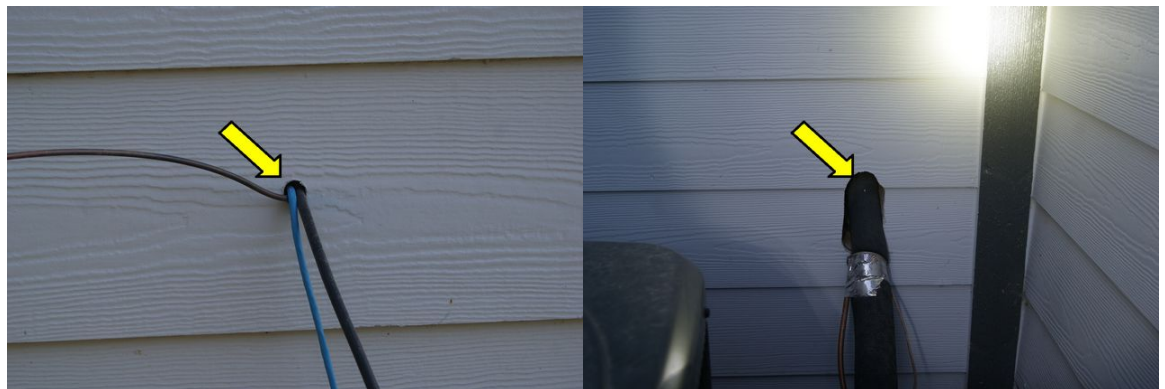
Exterior wall penetrations had gaps that should to be sealed with an appropriate sealant to prevent moisture and insect entry. All work should be performed by a qualified contractor.

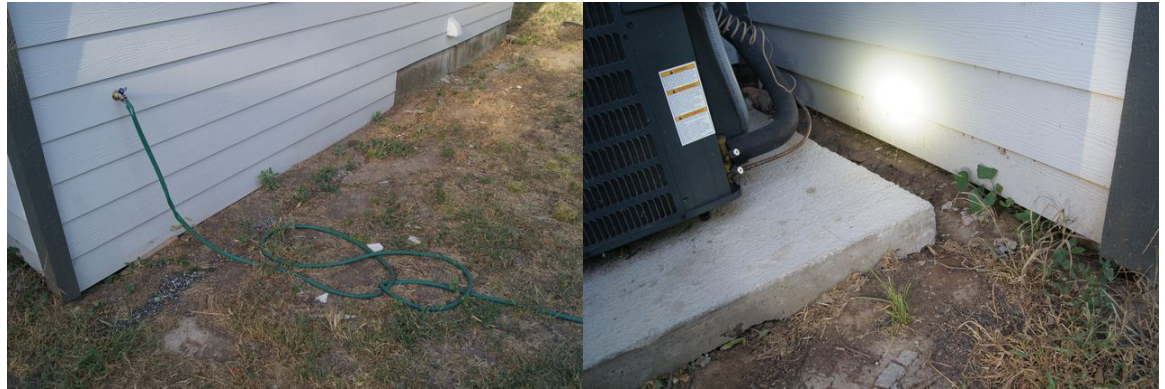
Wood siding covering exterior walls had inadequate clearance from grade. This condition may result in damage to lower courses of shingles from wood decay caused by moisture absorption. Wood siding should have a minimum clearance of 6 inches from grade.

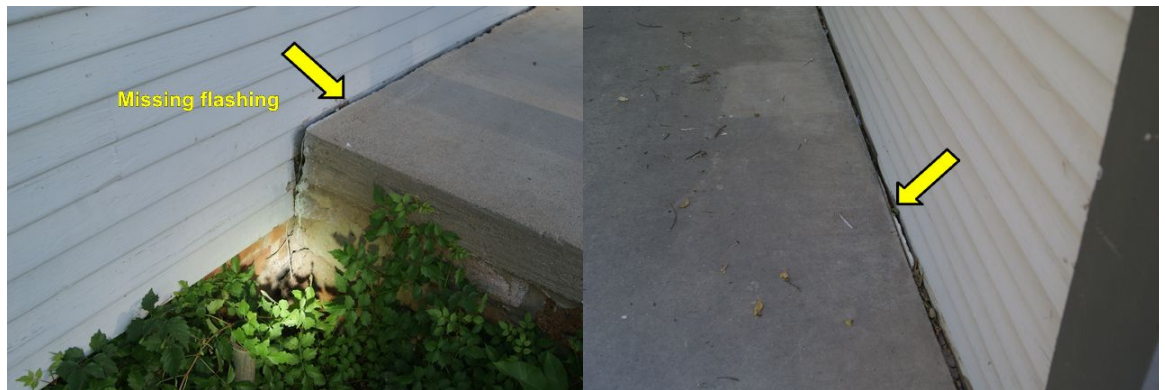
No flashing was installed at the lower termination of the exterior wall-covering material as is required by good building practice. This condition may result in moisture intrusion of the wall structure.

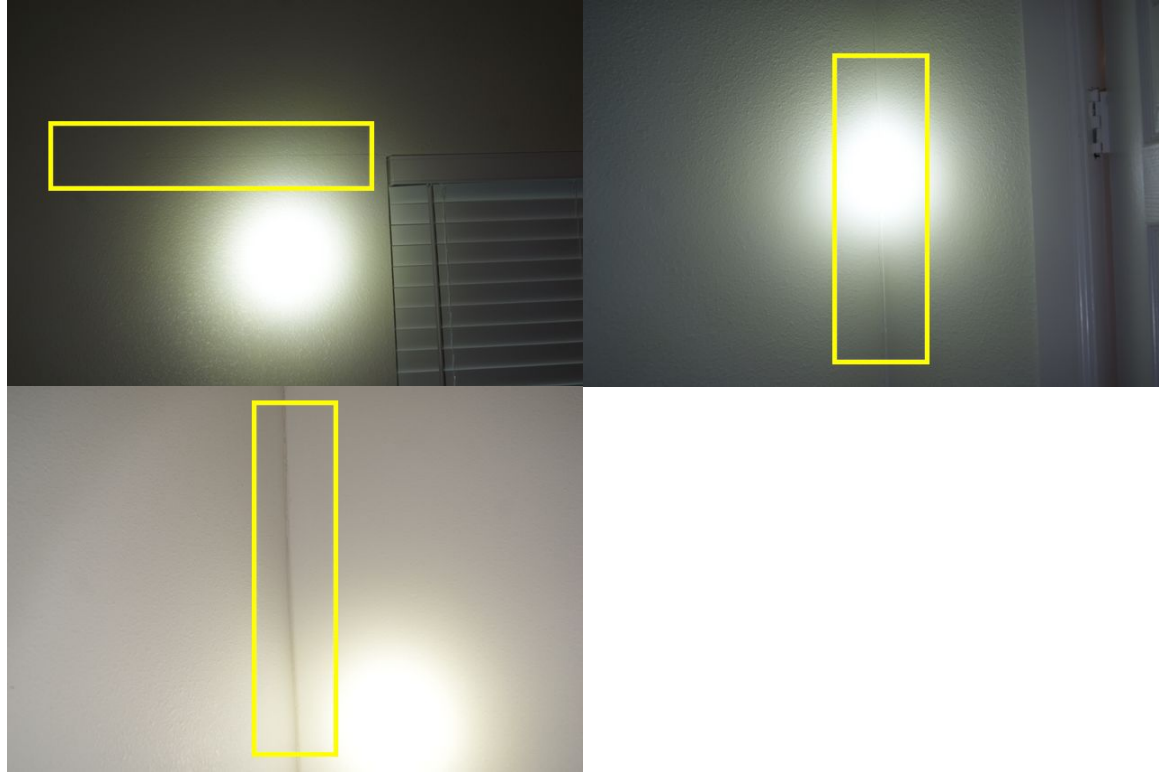
There were multiple cracks in the seams of the drywall, some were caulked. recommend repairs be made by qualified contractor.

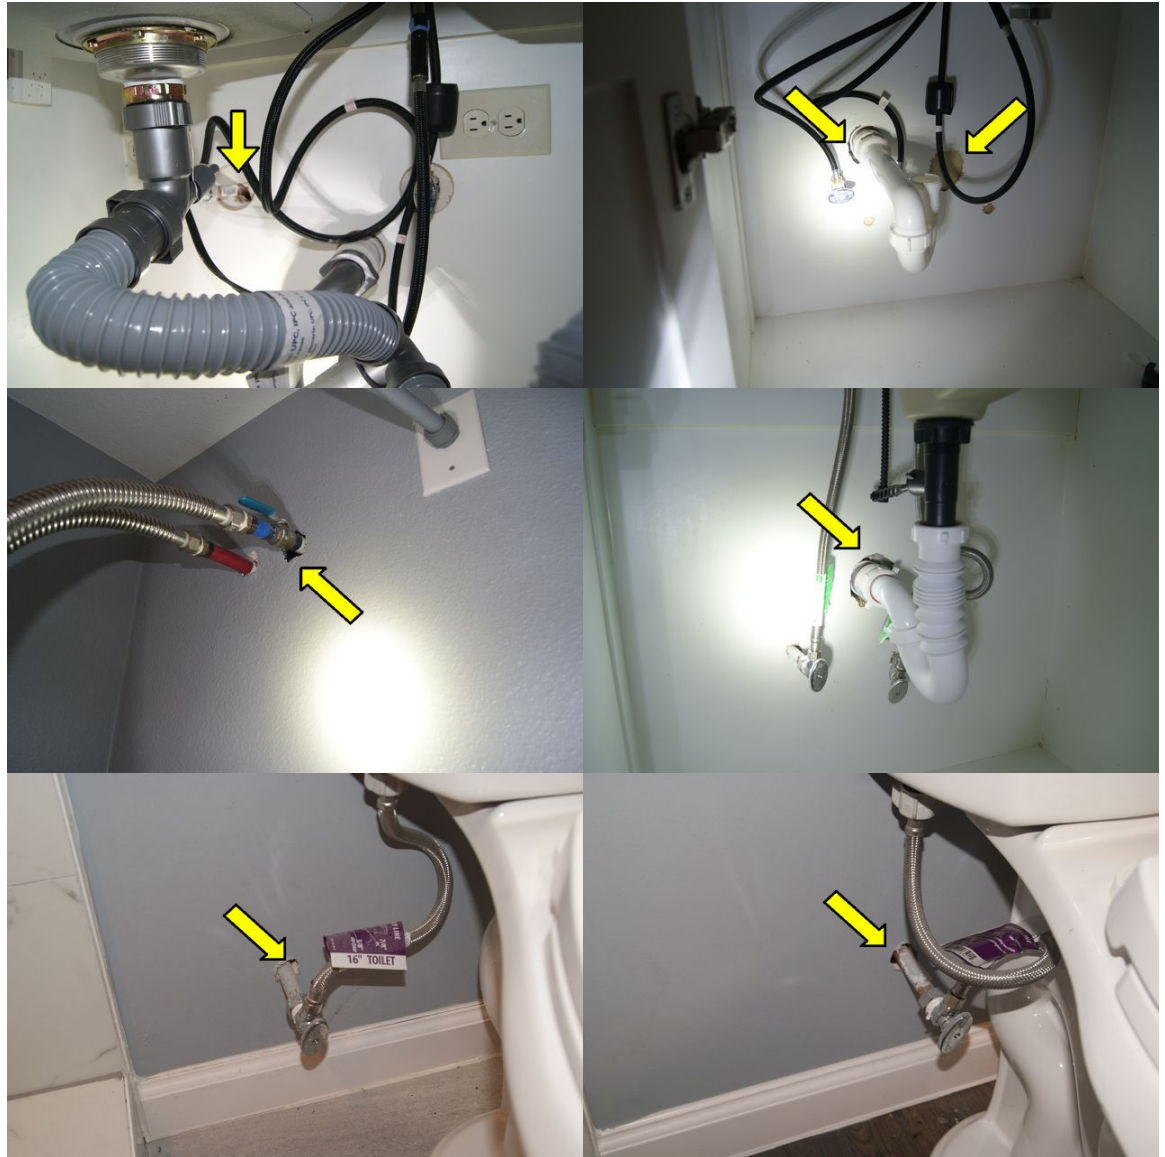
Walls under sinks were damaged and pipe penetrations did not have flanges to cover the gaps around the pipes.

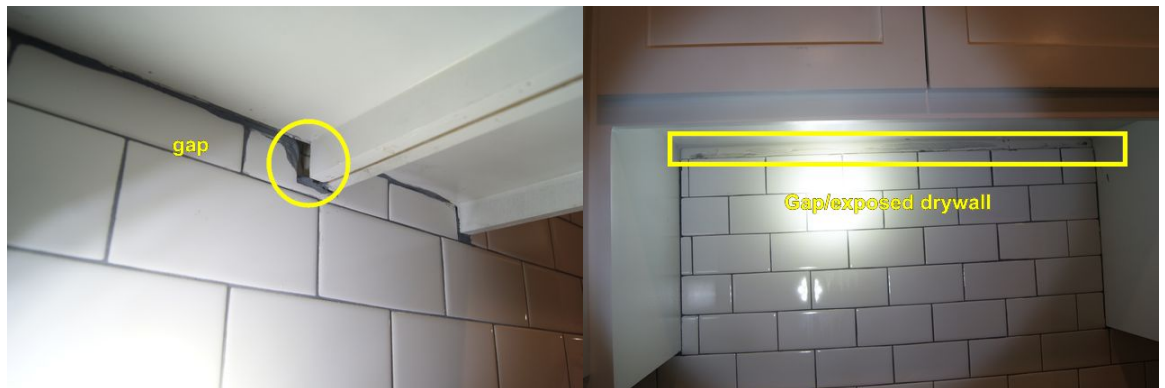
Wall tile in the kitchen was not completely installed at the time of the inspection. The Inspector recommends that before the expiration of your Inspection Objection Deadline you consult with a qualified contractor to discuss options and costs for completion.

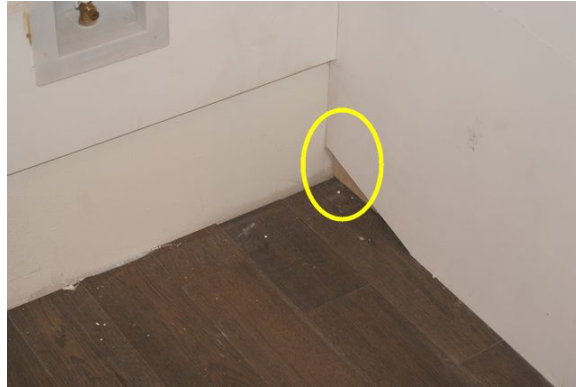
Missing baseboard behind refrigerator.

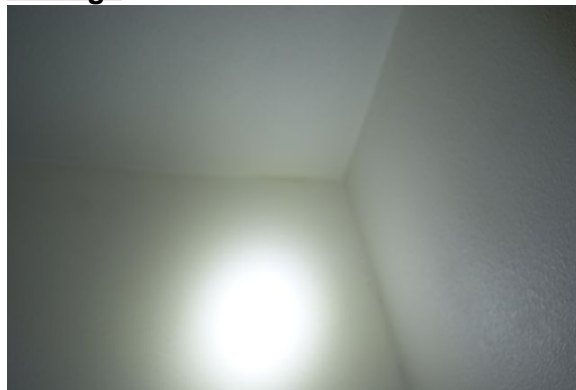
There was slight cracking at the seams in the front bedroom ceiling.

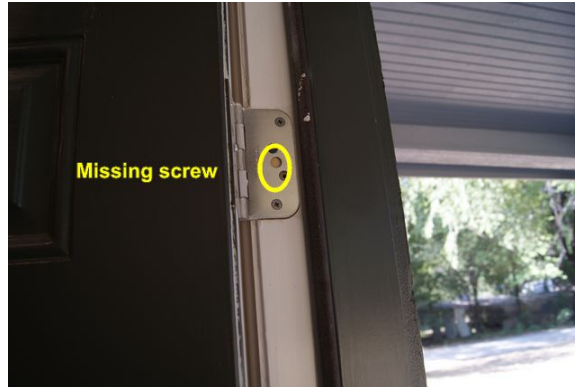
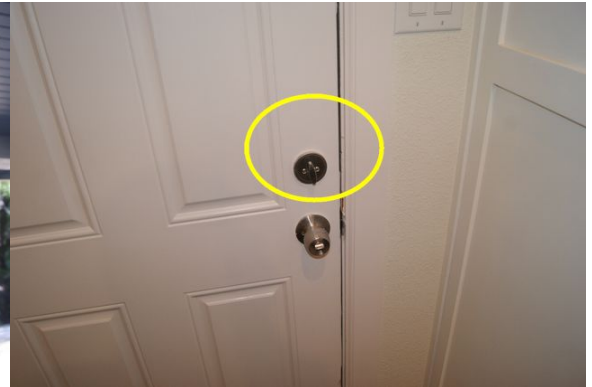
At a door to the exterior in the kitchen, the doorknob latch bolt did not align with the hole in the strike plate and did not hold the door closed. The Inspector recommends adjustment by a qualified contractor.

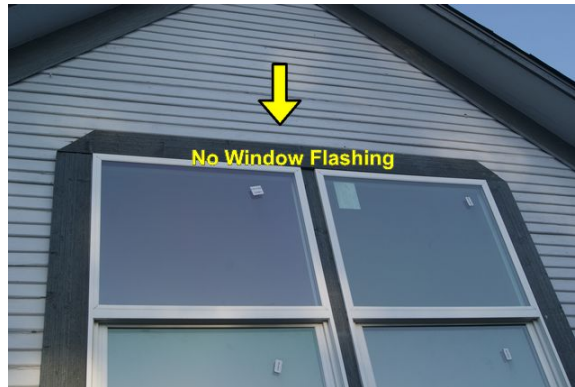
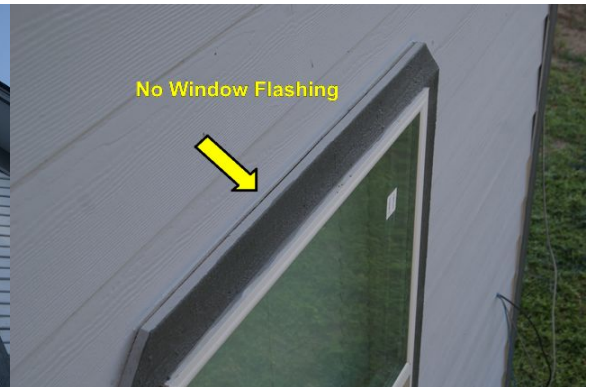
There was no flashing installed above exterior windows to help prevent moisture penetration into the walls

- ◆ There was no flashing installed above exterior windows to help prevent moisture penetration into the walls

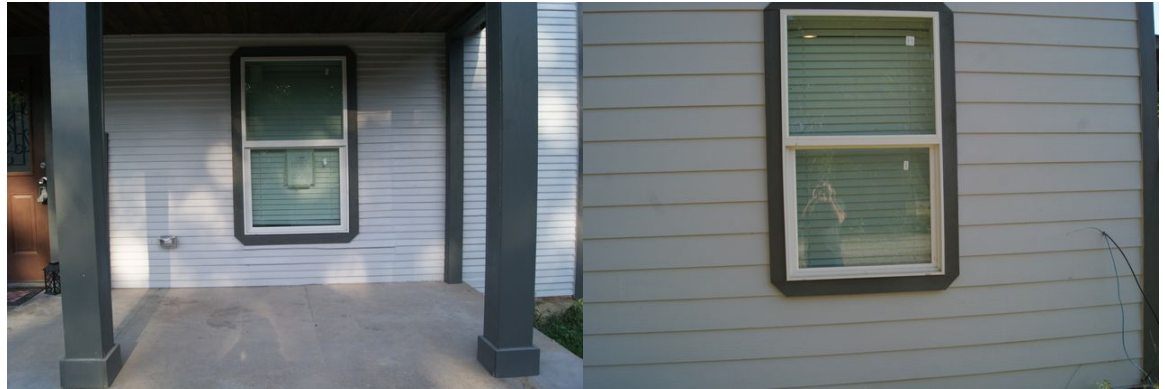
All windows are missing screens.

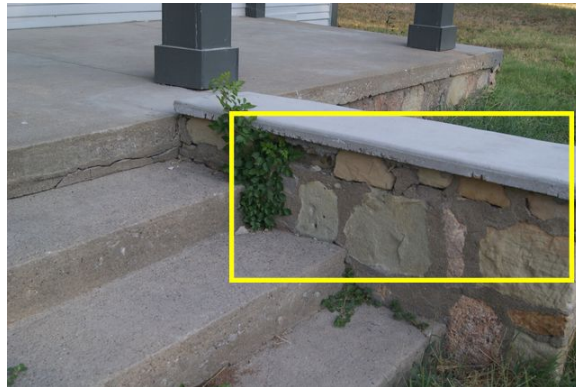
Mortar in stone stairway walls is deteriorated and should be repaired by a qualified contractor.

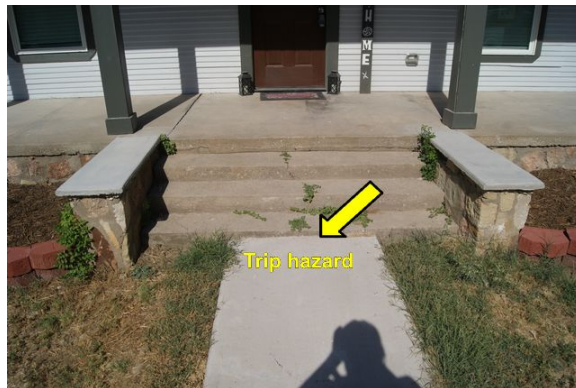
At the exterior staircase, the greatest riser height exceeded the lowest riser height by more than the 3/8 of an inch limit recommended by generally-accepted current standards. This condition is a potential trip hazard. All corrections should be made by a qualified contractor

- ◆ At the exterior staircase, the greatest riser height exceeded the lowest riser height by more than the 3/8 of an inch limit recommended by generally-accepted current standards. This condition is a potential trip hazard. All corrections should be made by a qualified contractor
- ◆ This exterior staircase had no handrail. Generally-accepted current safety standards mandate that stairs with 4 or more risers should have a handrail. You should consult with a qualified contractor before the expiration of your Inspection Objection Deadline to discuss options and costs for handrail installation.

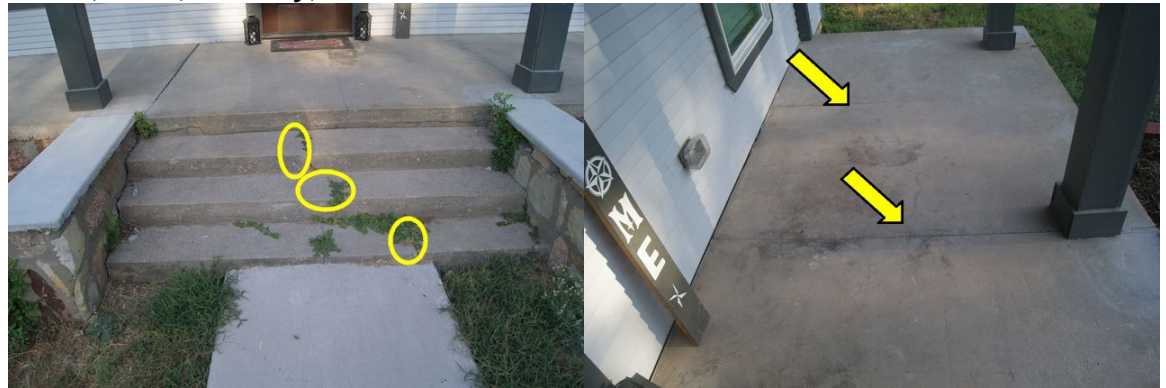
Common cracks (¼-inch or less) were visible in the concrete porch floor at the time of the inspection. Cracks exceeding ¼-inch should be filled with an appropriate sealant to avoid continued damage to the concrete porch floor surface from freezing moisture.

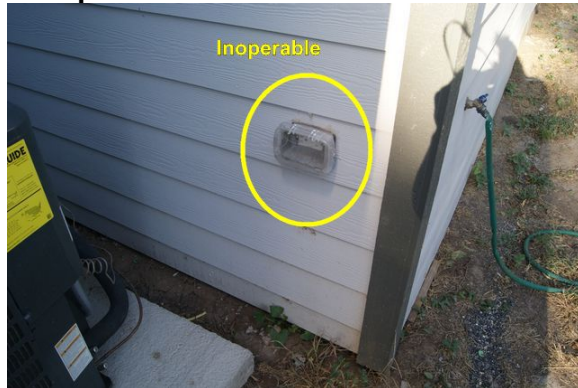
Exterior receptacle was inoperable at the time of inspection.

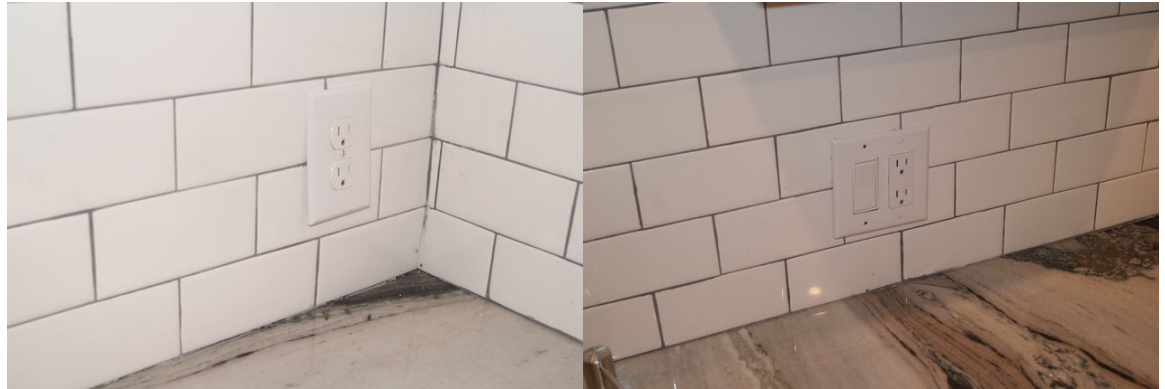
Receptacles in the kitchen were not secure to the wall.

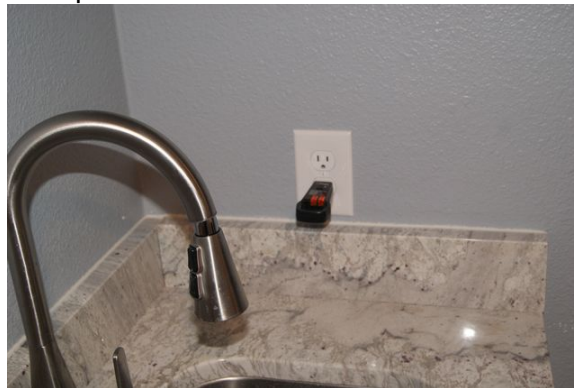
No ground fault circuit interrupter (GFCI) protection of home electrical receptacles was provided at the laundry room at the time of inspection. Although GFCI protection may not have been required at the time the home was built, for safety reasons, the Inspector recommends that electrical receptacles located in basements, crawlspaces, garages, the home exterior, and interior receptacles located within 6 feet of a plumbing fixture be provided with ground fault circuit interrupter (GFCI) protection in good working order to avoid potential electric shock or electrocution hazards. This can be achieved relatively inexpensively by: 1. Replacing an individual standard receptacle with a GFCI receptacle. 2. Replacing the circuit receptacle located closest to the electrical circuit overcurrent protection device (usually a breaker) with a GFCI receptacle. 3. Replacing the breaker currently protecting the electrical circuit that contains the receptacles of concern with a GFCI breaker.

- ◆ No ground fault circuit interrupter (GFCI) protection of home electrical receptacles was provided at the laundry room at the time of inspection. Although GFCI protection may not have been required at the time the home was built, for safety reasons, the Inspector recommends that electrical receptacles located in basements, crawlspaces, garages, the home exterior, and interior receptacles located within 6 feet of a plumbing fixture be provided with ground fault circuit interrupter (GFCI) protection in good working order to avoid potential electric shock or electrocution hazards. This can be achieved relatively inexpensively by: 1. Replacing an individual standard receptacle with a GFCI receptacle. 2. Replacing the circuit receptacle located closest to the electrical circuit overcurrent protection device (usually a breaker) with a GFCI receptacle. 3. Replacing the breaker currently protecting the electrical circuit that contains the receptacles of concern with a GFCI breaker.

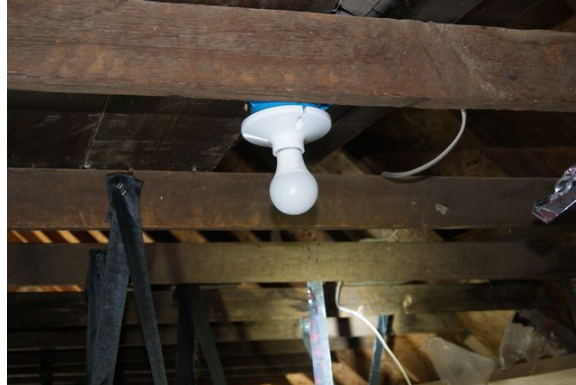
Light fixture is missing a protective cover.

- ◆ Light fixture is missing a protective cover.

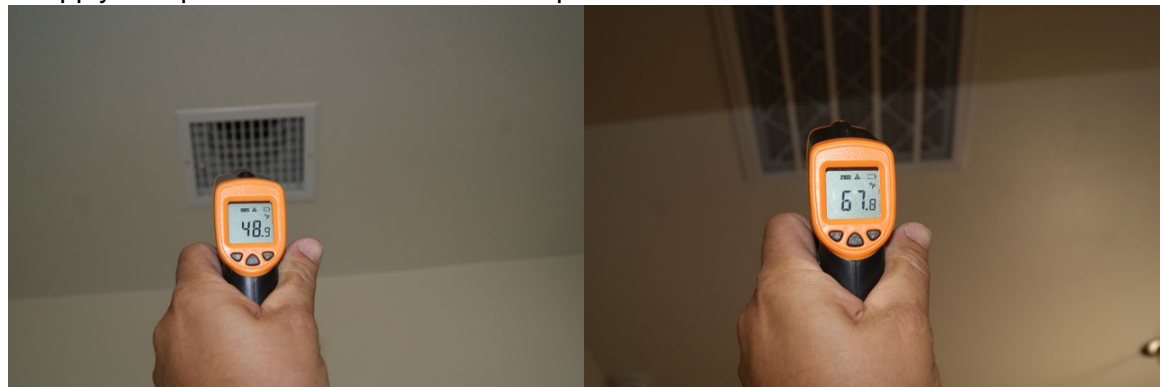
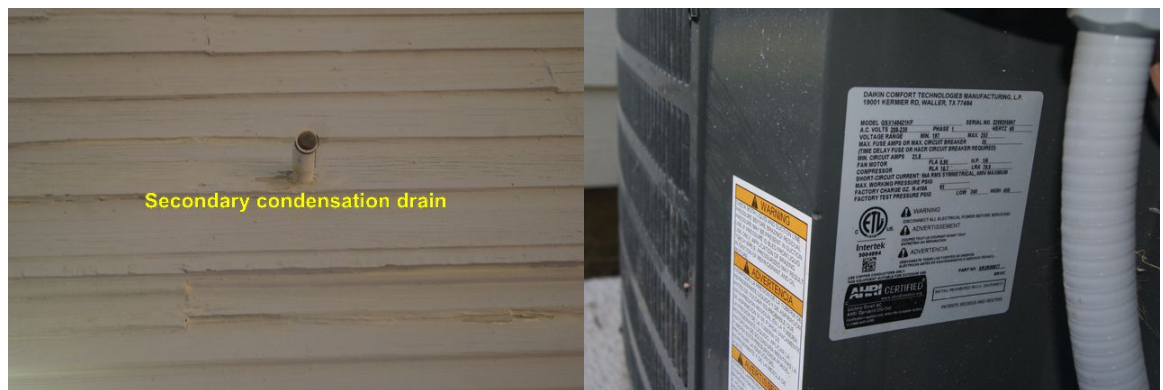
The A/C unit Calls for a Max 35 amp breaker and is connected to a 40 amp breaker. Inspector recommends further evaluation and repairs by qualified electrician. This may void any warranty on the A/C unit.

- ◆ The A/C unit Calls for a Max 35 amp breaker and is connected to a 40 amp breaker. Inspector recommends further evaluation and repairs by qualified electrician. This may void any warranty on the A/C unit.

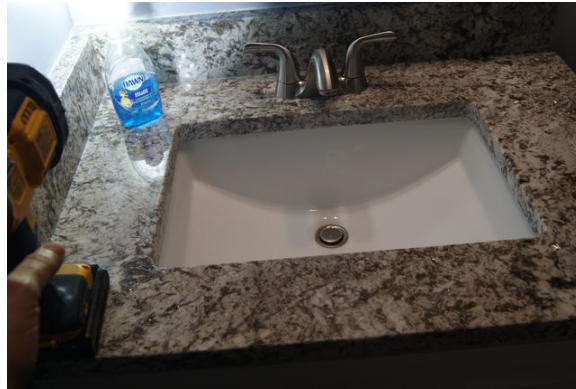
Multiple sinks were inoperable at the time of inspection.

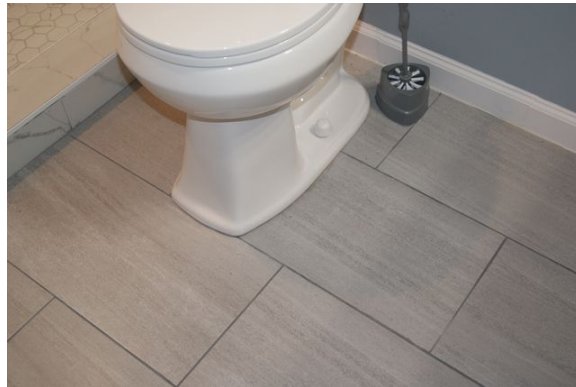
In the main floor hallway bathroom, the toilet was loose at the floor and should be re-attached by a qualified plumbing contractor.

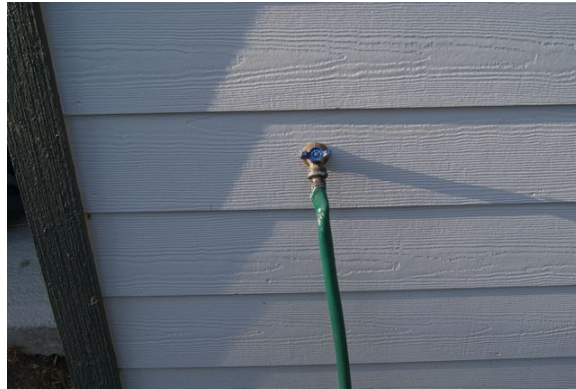
Exterior hose bibs do not have back-flow prevention device.

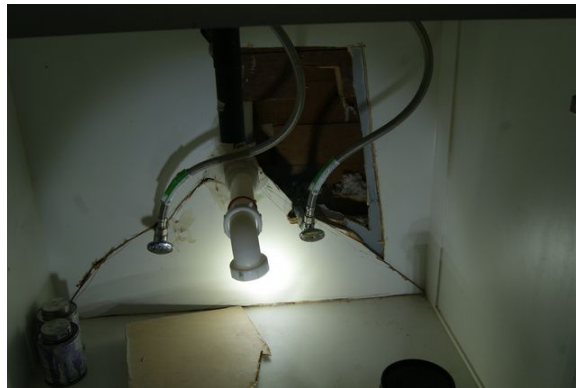
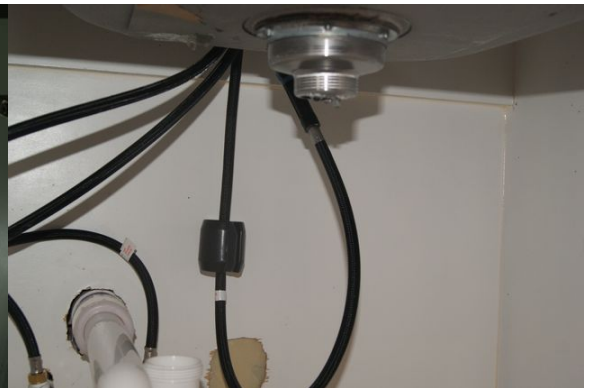
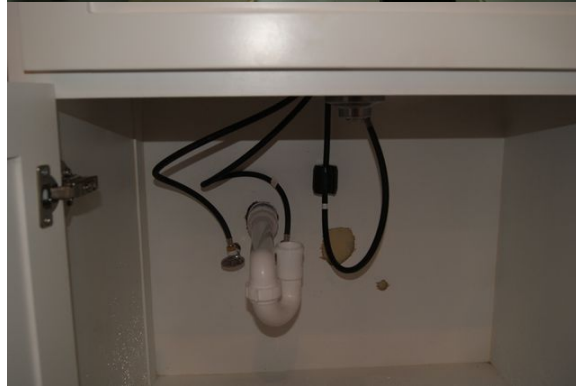
Drain line plumbing was inoperable at multiple sinks at the time of inspection.

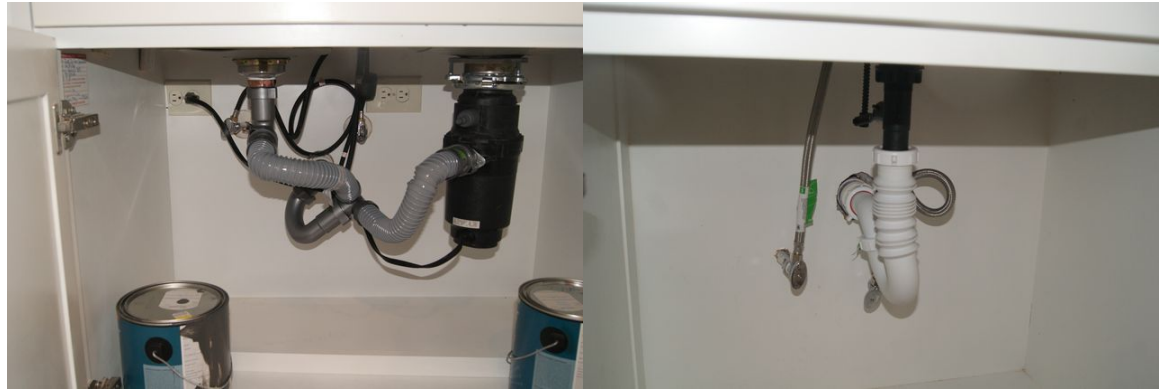
The home contained drain, waste or vent pipes of improper material which should be replaced with pipes of an approved material by a qualified plumbing contractor.

- ◆ The home contained drain, waste or vent pipes of improper material which should be replaced with pipes of an approved material by a qualified plumbing contractor.

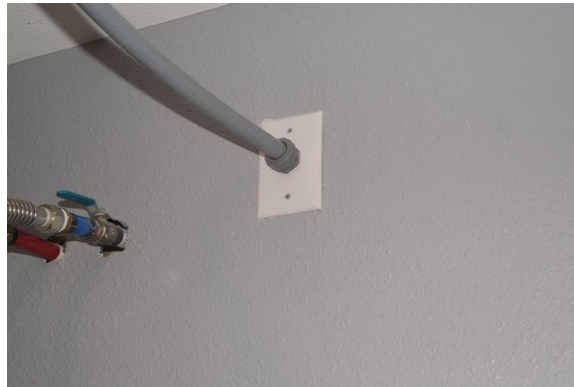
Electric water heater did not have a quick disconnect within reach of the unit. Recommend correction by a qualified electrician.

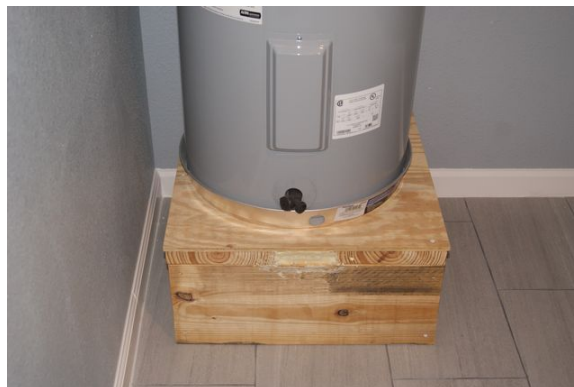
The drip pan installed to prevent water damage in the event leakage of the water heater tank or plumbing connections appeared to be inadequate. Drip pans should be a minimum of 1½ inches deep and of sufficient size and shape to receive all leakage and condensate. The pan should be drained by a properly-terminated pipe with a minimum inside diameter of ¾ inch. The Inspector recommends correction by a qualified plumbing contractor.

- ◆ The drip pan installed to prevent water damage in the event leakage of the water heater tank or plumbing connections appeared to be inadequate. Drip pans should be a minimum of 1½ inches deep and of sufficient size and shape to receive all leakage and condensate. The pan should be drained by a properly-terminated pipe with a minimum inside diameter of ¾ inch. The Inspector recommends correction by a qualified plumbing contractor.

Recommend non metallic drain pan for electric water heaters.

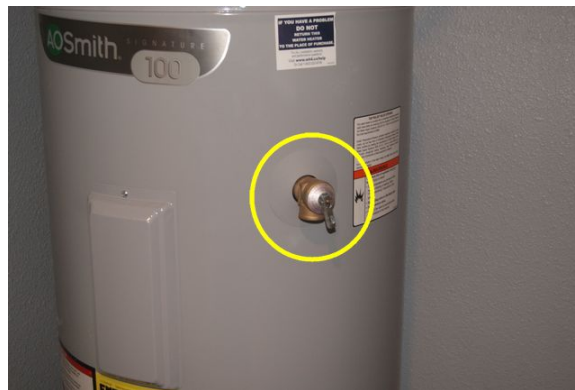
The temperature/pressure relief (TPR) valve had no discharge pipe installed. If the valve were to activate while a person was nearby, that person could be badly burned. The Inspector recommends that a properly-configured TPR discharge pipe be installed by a qualified plumbing contractor. The TPR VALVE SHOULD NOT BE TESTED UNTIL A PROPER DISCHARGE PIPE HAS BEEN INSTALLED

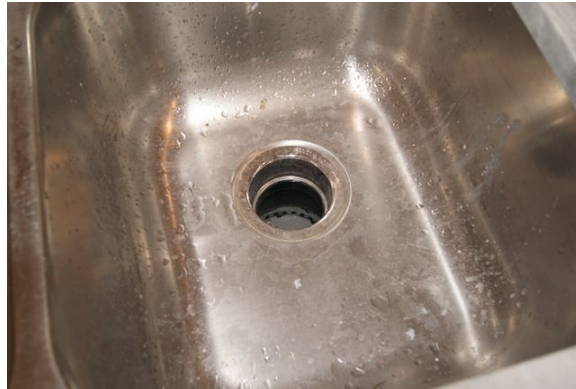
The garbage disposal was missing the rubber insert at the time of the inspection. A new insert should be installed to prevent injury from items ejected during disposal operation.

- ◆ The garbage disposal was missing the rubber insert at the time of the inspection. A new insert should be installed to prevent injury from items ejected during disposal operation.

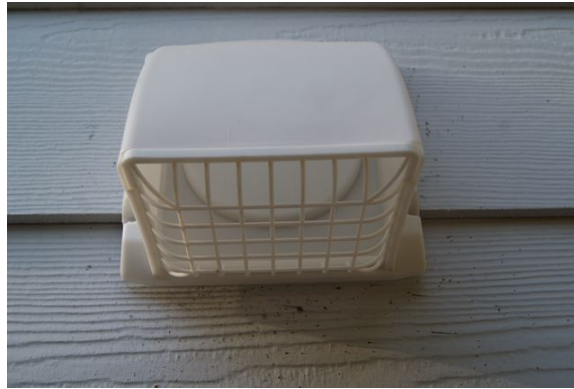
Screens at dryer vent terminations are no longer allowed in new construction for safety reasons. The Inspector recommends that the dryer vent termination be changed to comply with modern safety recommendations. All work should be performed by a qualified contractor.
